# Mobile Intel<sup>®</sup> Pentium<sup>®</sup> II Processor Specification Update

Release Date: September 2006

Order Number: 243887-055

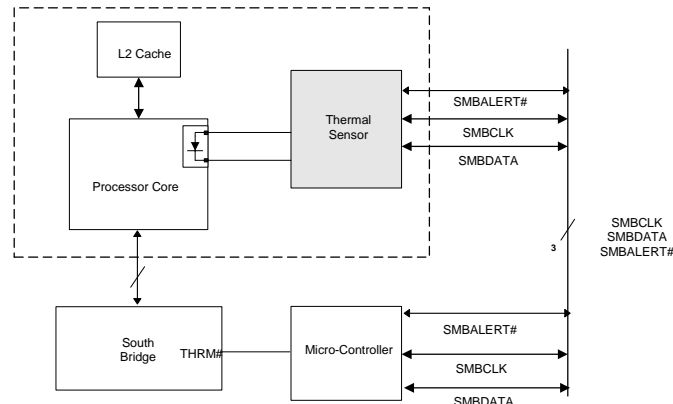
**Figure 1. An Example of Microcontroller Driven Thermal Management**

### B30. Thermal Sensor May Assert SMBALERT# Incorrectly

**Problem:** The Mobile Pentium II processor and the Pentium II Processor Mobile Module have a thermal sensor that monitors the processor core's temperature. Please note that desktop systems could have a similar thermal device. The thermal sensor asserts SMBALERT# if the processor temperature exceeds the temperature limits set in the Alarm Threshold Registers ( $T_{HIGH}$ ,  $T_{LOW}$ ). It also sets the corresponding Status Register bits to identify the cause of the interrupt. Figure 1 gives one example of how the SMBALERT# signal could be used in a system.

Under the conditions described below, the thermal sensor incorrectly generates the SMBALERT# interrupt. All of the following conditions must be met to trigger a false interrupt:
